Sun Fire™ V440 Server Product Notes

Part No. 816-7733-13
October 2003, Revision A

Product Notes

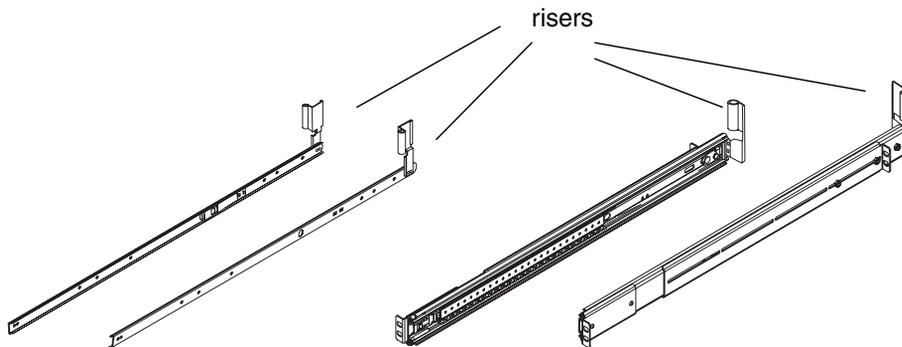
The Inner Glides and Slide Assemblies Incorrectly Illustrated

In the Sun Fire V440 server documentation set, the slide assemblies and inner glides used for rackmounting are incorrectly shown in the illustrations. The slide assemblies and inner glides have risers at the back ends that lift the cable management arm above the cable connectors. The illustration below shows the correct slide assemblies and inner glides.

Install the inner glides and slide assemblies so that the risers point up. Each piece is labeled “LEFT” or “RIGHT” to indicate where it should be installed, as viewed from the front of the server.
