Brocade Fabric OS v2.6.1

Brocade OEM Final Disclosure Notes

May 2, 2003

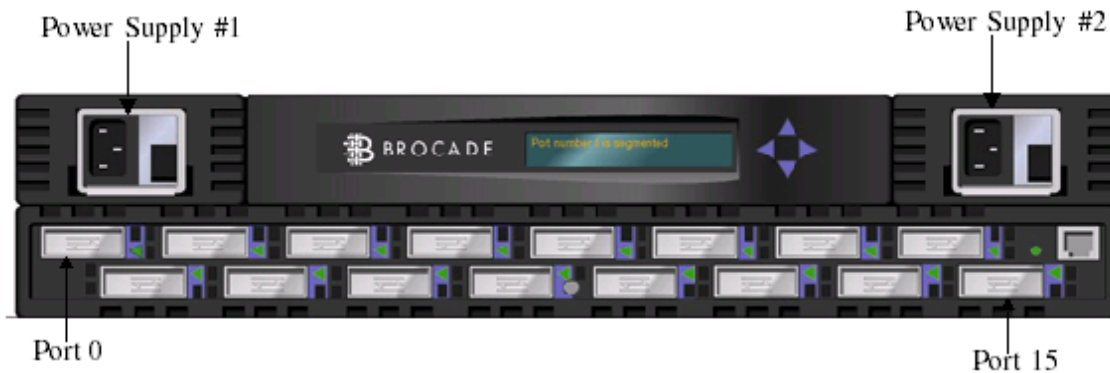
Figure 1-1 on page 1-1 of the *SilkWorm 2800 Hardware Reference Manual*, has mis-labeled call-outs. The power supplies 1 and 2 are reversed, and should be labeled as follows:

DEFECT000025642	Medium	<p>Summary: Turning one of two power supplies off causes switch to reboot 2800 due to HW ref guide list the power supplies backwards.</p> <p>Symptom: Switch reboot</p> <p>Solution: Defer: HW ref guide need to be updated</p> <p>Probability: Low</p>
DEFECT000025646	Medium	<p>Summary: "supportshow" command will display close to infinite faultTrace (very large).</p> <p>Symptom: supportshow continues to dump stack trace due to long user stack length field.</p> <p>Solution: Check on invalid filed length</p> <p>Workaround: None</p> <p>Customer Impact: Fix is going to 2.6.1a patch release</p> <p>Probability: Low.</p>
