Brocade Fabric OS v2.6.1 Release Notes

May 2, 2003

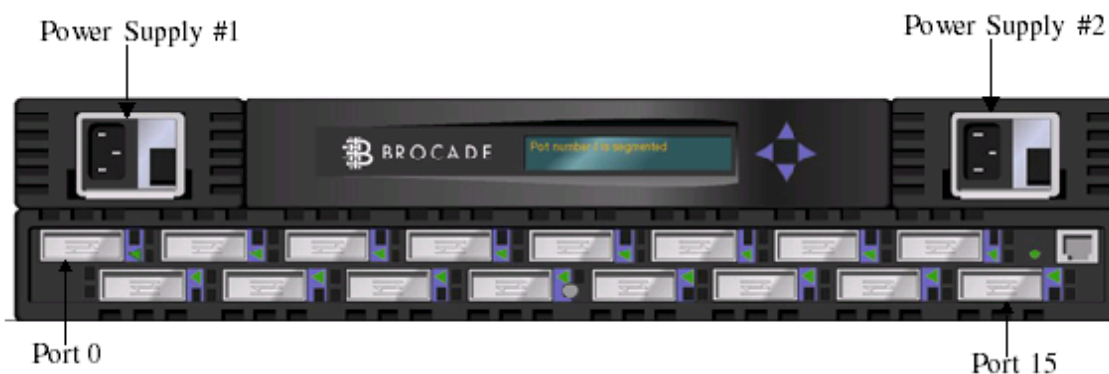
Figure 1-1 on page 1-1 of the *SilkWorm 2800 Hardware Reference Manual*, has mis-labeled call-outs. The power supplies 1 and 2 are reversed, and should be labeled as follows:

DEFECT000025642	Medium	<p>Summary: Turning one of two power supplies off causes switch to reboot 2800 due to HW ref guide list the power supplies backwards.</p> <p>Symptom: Switch reboot</p> <p>Solution: Defer: HW ref guide need to be updated</p> <p>Probability: Low</p>
DEFECT000025646	Medium	<p>Summary: "supportshow" command will display close to infinite faultTrace (very large).</p> <p>Symptom: supportshow continues to dump stack trace due to long user stack length field.</p> <p>Solution: Check on invalid filed length</p> <p>Workaround: None</p> <p>Customer Impact: Fix is going to 2.6.1a patch release</p> <p>Probability: Low.</p>
