Sun Microsystems, Inc.

Best Practices Guide

Addressing: E-Cache Parity Errors

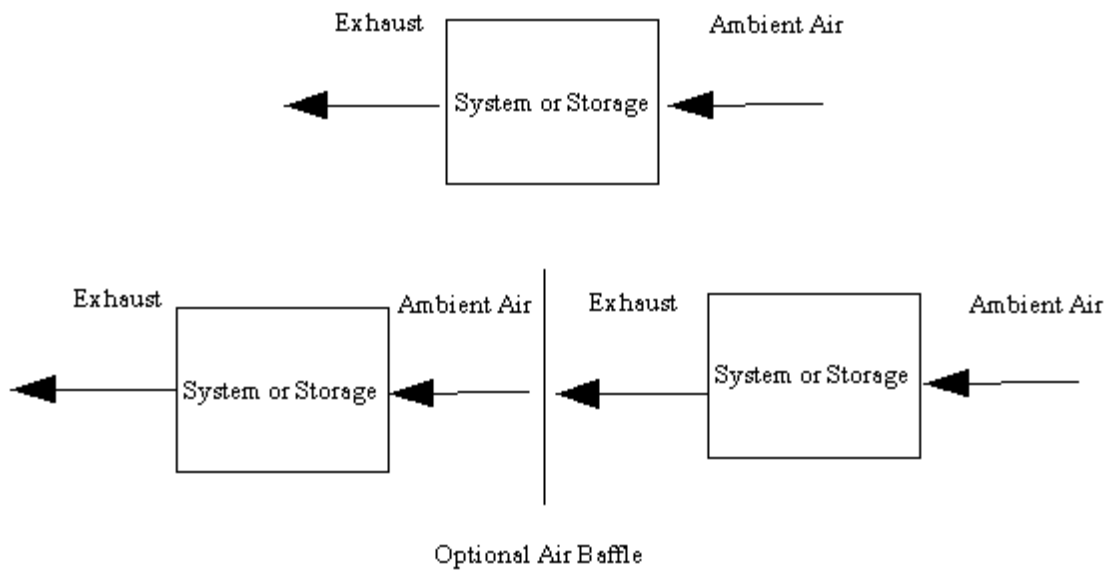
**Figure 2 – Better System Placement**

A better solution is to alternate the placement of these side air flow systems. This allows the exhaust of one system to cool to a sufficient level before it is used as incoming air to the second system. As noted, an optional baffle can be installed to help divert heated air if the required distance between the systems is not sufficient.
